MISCELLANEOUS PAPER CERC-89-5

# THE LAKESHORE PARK, ASHTABULA, OHIO, BREAKWATER PROJECT

Julie Dean Rosati, Joan Pope, Thomas Bender  
Clifford L. Truitt

Coastal Engineering Research Center

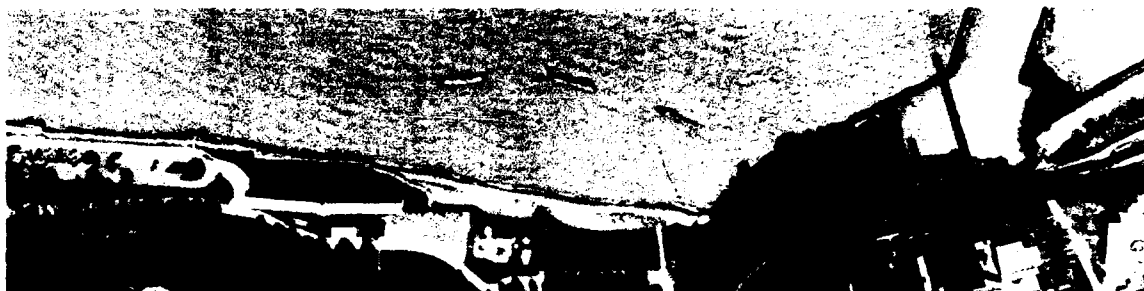
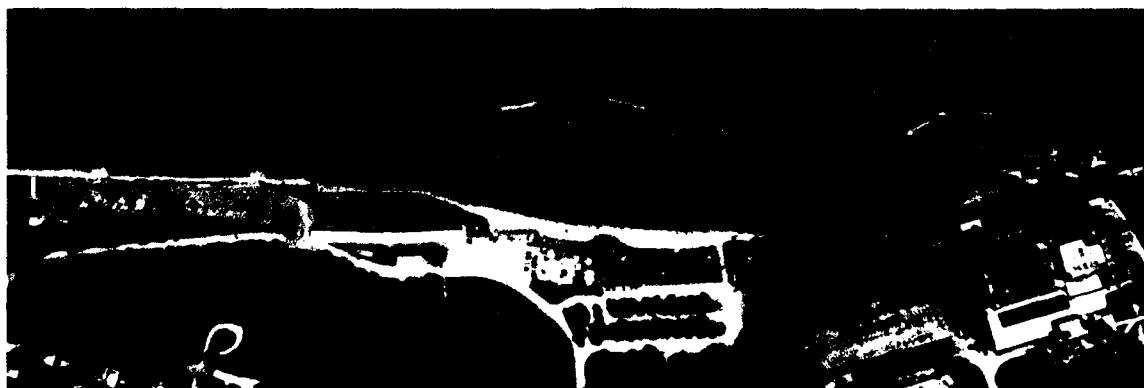
a. 14 December 1982, mean daily lake level = 570.86 ft LWD

b. 2 October 1984, mean daily lake level = 571.84 ft LWD

c. 14 November 1984, mean daily lake level = 571.53 ft LWD

d. 24 July 1985, mean daily lake level = 572.93 ft LWD

Figure 3. Lakeshore Park controlled aerial photographs

12. Controlled aerial photographs at a scale of 1:4800 were included in the monitoring program to provide a qualitative history of the project shoreline evolution. These photos were taken in December 1982, October 1984, November 1984, and July 1985 and are presented in Figure 3 along with the mean lake level on the day of the aerial photographs. Immediately after construction (aerial photograph, December 1982), there was a very slight sinuosity of the beach planform, indicating some influence of the breakwater on the beach. However, as the beach eroded, the shoreline response in later photographs becomes negligible. All the aerial photographs except for July 1985 indicate some reflection of incoming waves off the CEI intake structure.

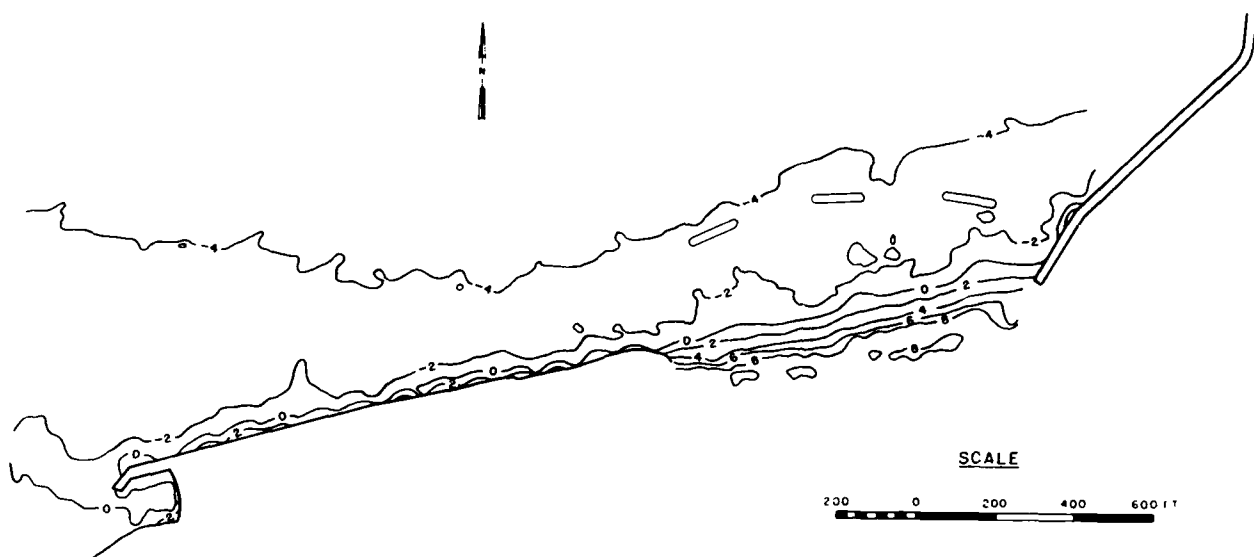
Figure 7. June 1983 contour plot (feet relative to LWD)
